IV. SURVEY RESULTS

A. Architectural Resources

The following is an explanation of the results of the architectural survey conducted for the resources within the Area of Potential Effect (APE) for the Route 9 and Road 319 Intersection Improvements Project. Included are the architectural descriptions and a preliminary eligibility recommendation for each of the surveyed properties. Delaware Cultural Resource Survey forms for these properties can be found in *Appendix A*.

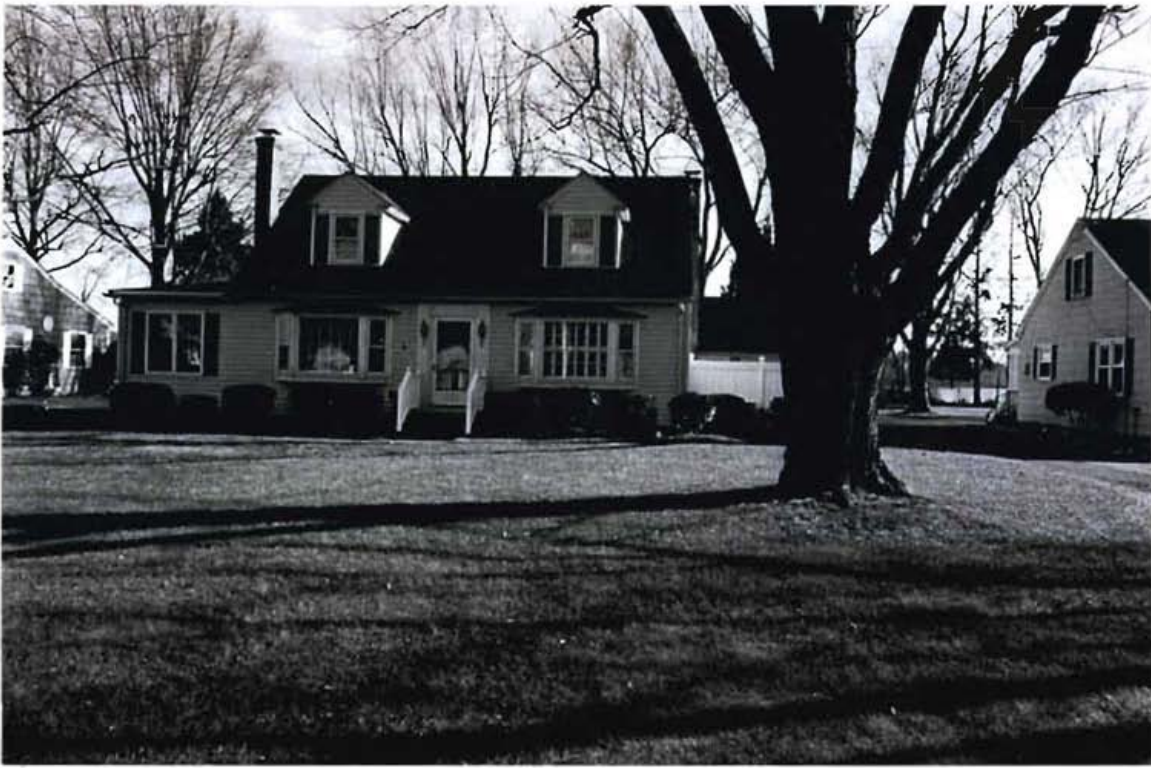
818 Route 9 (tax parcel 1-35-15-123) is a rectangular one and one-half story dwelling in Georgetown Hundred, Sussex County, Delaware. The building is set back approximately two hundred feet from US Route 9 on a lightly wooded lot; the surrounding buildings are somewhat closely placed and of similar mid-twentieth century suburban residential styles. 818 Route 9 is a Cape Cod/Colonial Revival-style building with two gable-roofed dormers. The roof is somewhat steeply pitched and large, and covered with asphalt shingles. On the north end of the east façade is a brick exterior end chimney with a corbelled top. The house is covered with light blue vinyl siding; the shutters are a darker blue. The foundation is concrete and has small windows, suggesting that the house has a basement. The first floor has a central entry with a paneled door with four small rectangular lights at its top. This door has a wide white surround and flanking lights within the surround. The door is accessed via a brick stoop with three steps and white porch-type railings. Flanking the door on the first story are identical tripartite bay windows; all portions have vinyl snap-in muntins. On the second story, the dormer windows are vinyl, with double-hung sash, snap-in muntins, simple surrounds, and shutters. Windows on the secondary facades are similar to those in the dormers, and are either single or paired; most have shutters. On the east façade is a one-story porch addition with a slightly hipped roof and double and triple windows; again, these are vinyl with snap-in muntins. To the rear and slightly west of the house is a large gable-roofed garage. A tall, solid, L-shaped fence connects the rear of this outbuilding to the west façade of the house.

Photograph 1: Elevation of S-10124, facing south from Route 9.

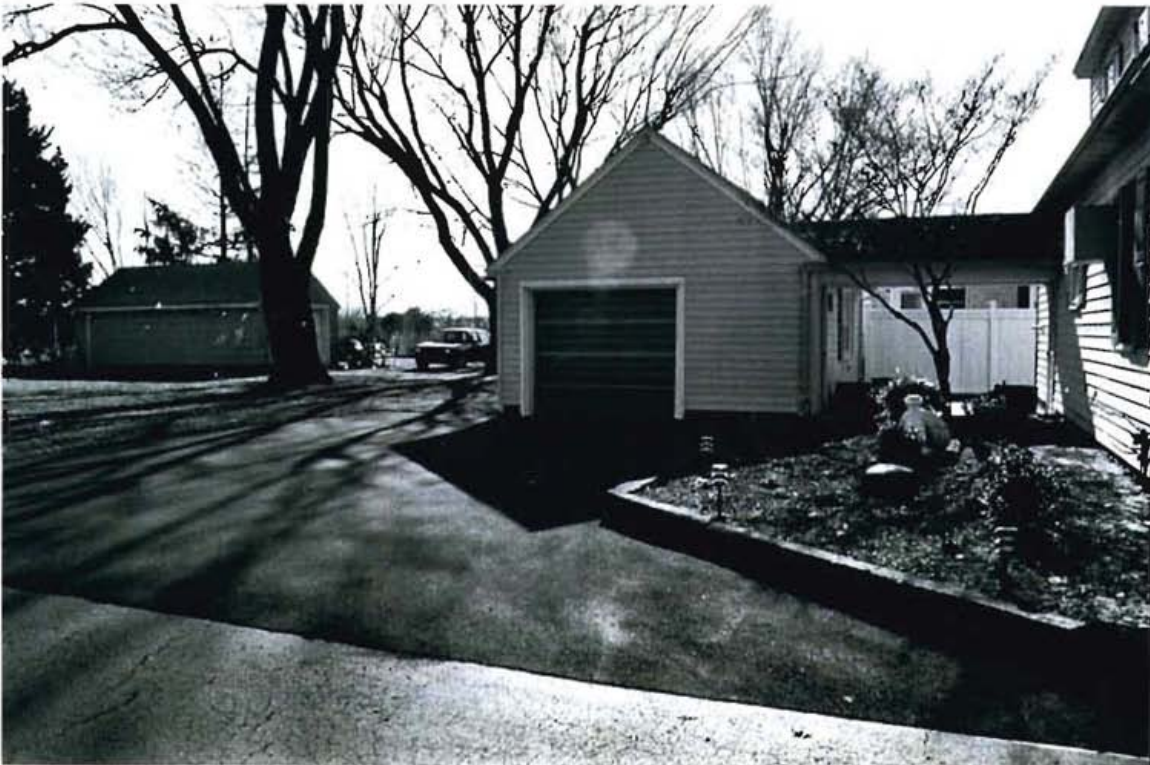
Photograph 2: Lateral view of garage at S-10124, facing west.

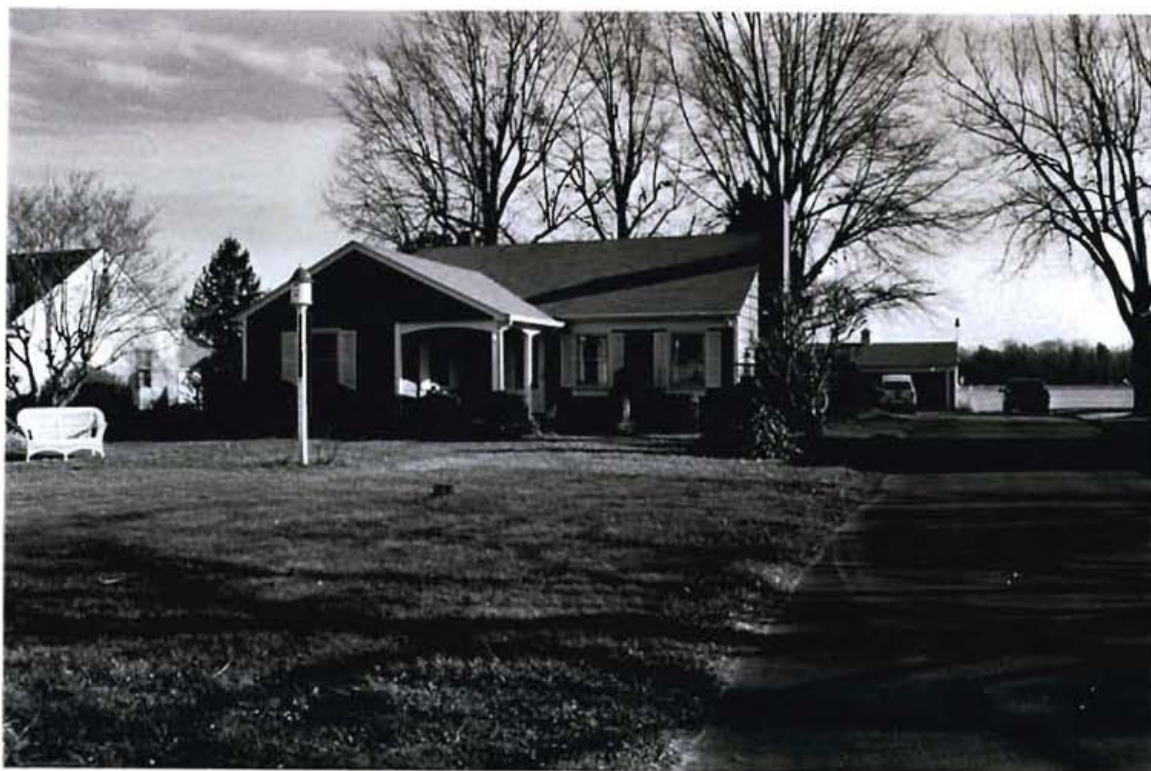
820 Route 9 (tax parcel 1-35-15-122) is an L-shaped, one and one-half story dwelling in Georgetown Hundred, Sussex County, Delaware. The building is set back approximately two hundred feet from US Route 9 on a lightly wooded lot; the surrounding buildings are somewhat closely placed and of similar mid-twentieth century suburban residential styles. 820 Route 9 is a Minimal Traditional style building, with one front-facing gable that incorporates a porch sheltering the entry on the side-gabled portion of the house. The roof is moderately pitched and covered with asphalt shingles; the siding is dark blue asbestos shingles. The windows are vinyl with snap-in muntins and white louvered shutters; they are evenly spaced on the cross-gable and front (north) façade, and somewhat more irregular but of similar style and materials on the secondary facades. A brick exterior end chimney is located on the west façade. To the rear and slightly west of the dwelling is a large, side-gabled two-car garage with a ventilation unit in the center of the roof ridge. A paved driveway on the west side of the house leads to this garage.

Photograph 1: Lateral view of S-10125, facing south from Route 9.

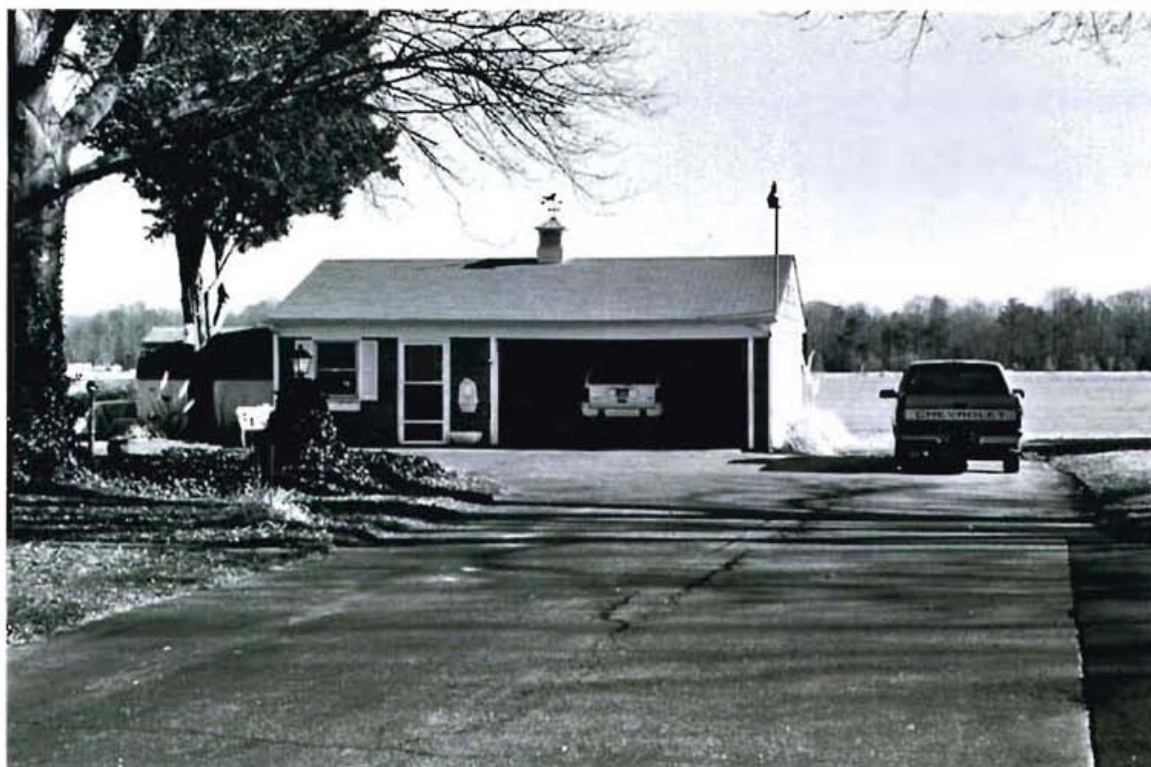
Photograph 2: Lateral view of garage at S-10125, facing south.

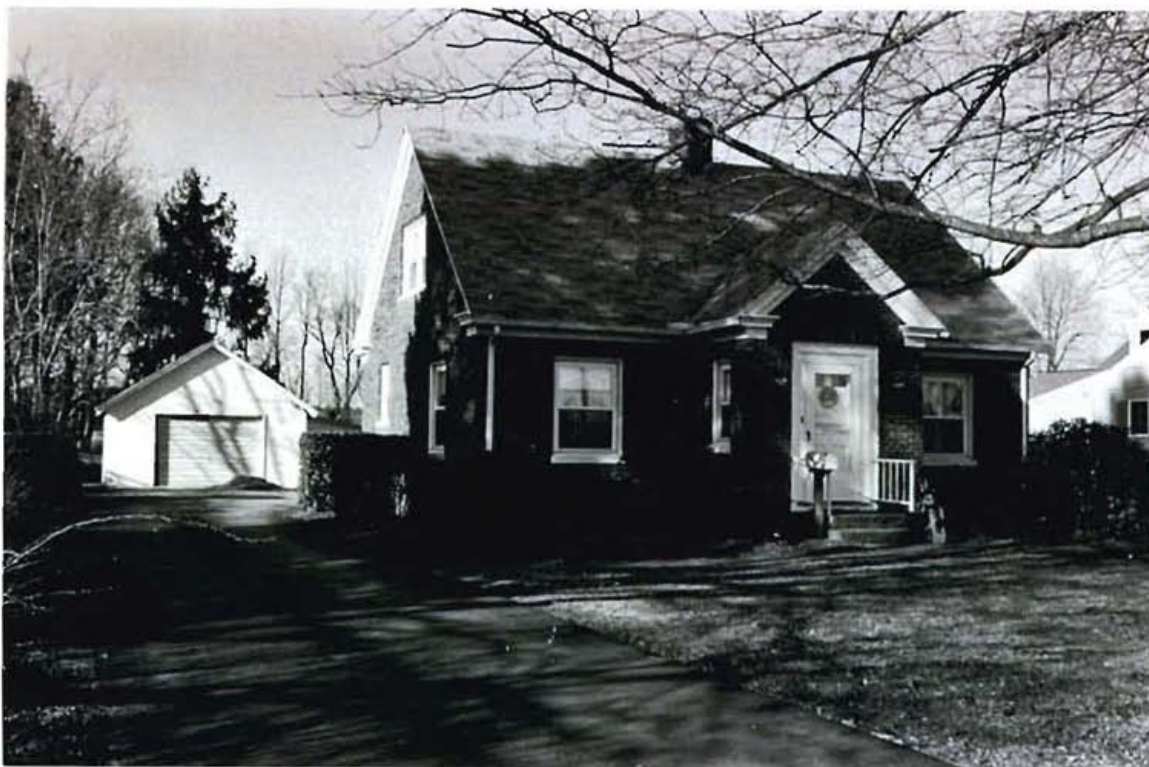
821 Route 9 (tax parcel 1-35-15-22) is a three bay, two story, c. 1954, Cape Cod-style single-family dwelling with an asphalt-shingle, side gable roof, clinker brick exterior, and vinyl sash replacement windows. A centered brick chimney is seen in the ridgeline.

The front (south) façade faces Route 9, and features a centered, projecting entry with a four panel, two light entry, flanked by two single one-over-one vinyl sash replacement windows. The side (west) façade features two single one-over-one vinyl sash replacement windows of varying sizes on the first story, and a paired one-over-one vinyl sash replacement window in the gable peak. The opposing (east) side façade features similar fenestration, but the two windows on the first floor are both similar in size.

Photograph 1: Lateral view of S-10126, facing northeast from Route 9.

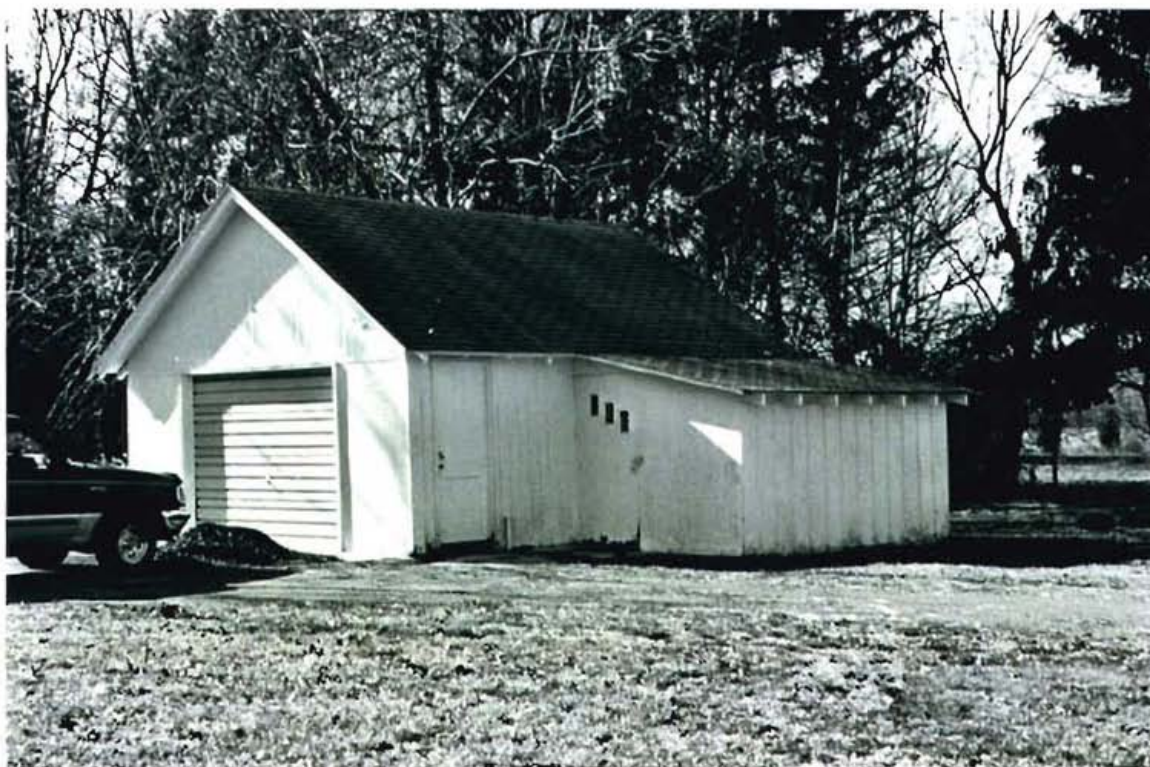
A one and one-half story weatherboard garage is located northwest of the dwelling. This structure features a large fiberglass vehicular door along the front (south) façade, an asphalt shingle, front gable roof, and exposed rafter tails. Based on physical appearance, this garage was likely constructed at the same time as the dwelling (c. 1954).

Photograph 2: Lateral view of garage at S-10126, facing northwest.

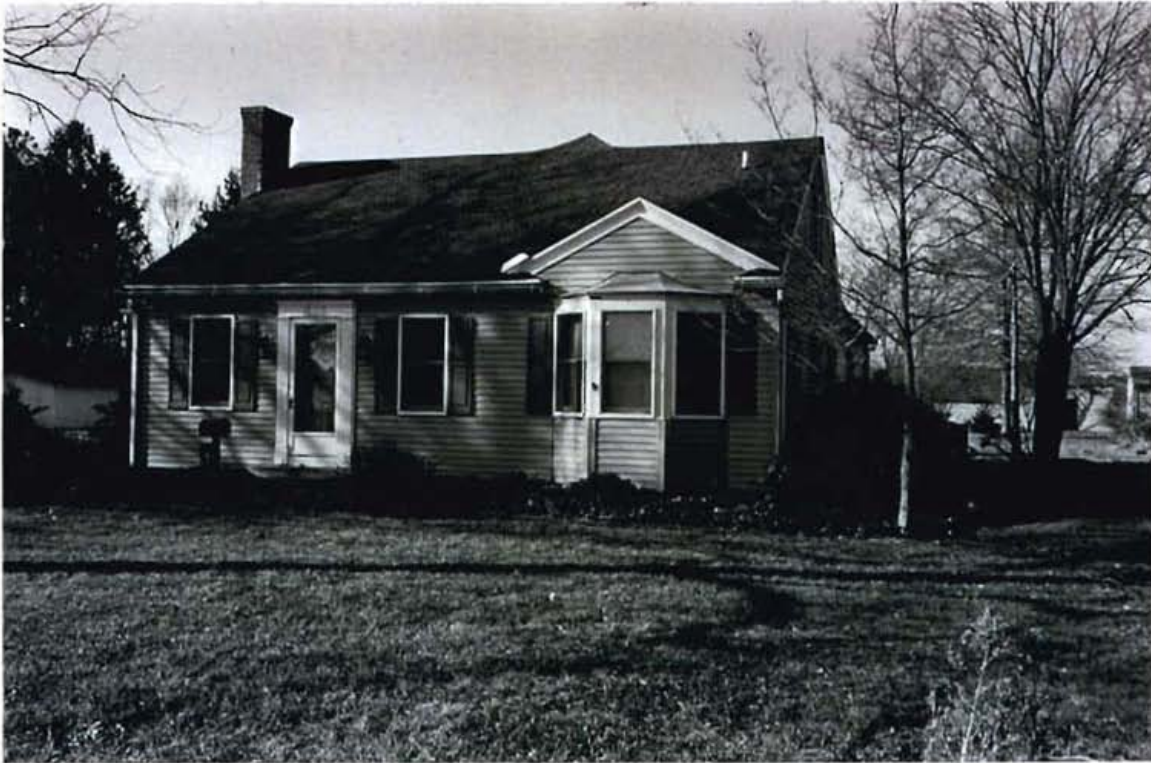
823 Route 9 (tax parcel 1-35-15-23) is a c. 1954, two story, four bay, Cape Cod-style single-family dwelling with vinyl exterior siding, and an asphalt-shingle, side gable roof. An exterior brick chimney is seen along the side (west) façade. All windows are vinyl sash replacement windows with snap-in muntins and fixed vinyl sash shutters.

The front (south) façade fronts Route 9, and features a single, vinyl sash replacement window with snap-in muntins in the western bay. Moving from west to east, the second bay contains a four-panel entry with two lights with decorative fluted surrounds and a crown. The third bay features fenestration similar to the first bay, and the easternmost bay contains a vinyl sash replacement bay window.

Photograph 1: Lateral view of S-10127, facing north from Route 9.

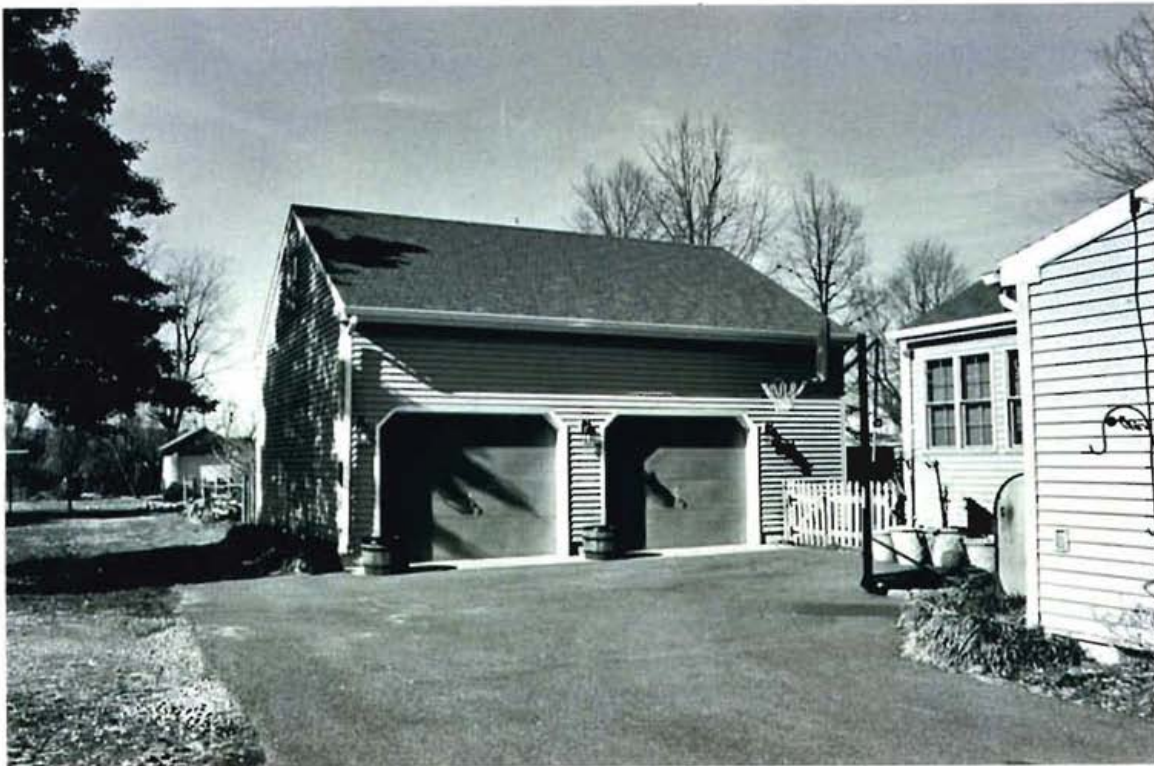
A two bay, one and one-half story, vinyl sided, asphalt shingle, side gable vehicular garage is located north of the dwelling. Based on physical appearance, this garage was likely constructed after the main dwelling. The front (south) façade contains two single large vehicular doors. A small shed is also located north of the garage in the northwest corner of the tax parcel.

Photograph 2: Lateral view of garage at S-10127, facing northeast. Note second garage in background.

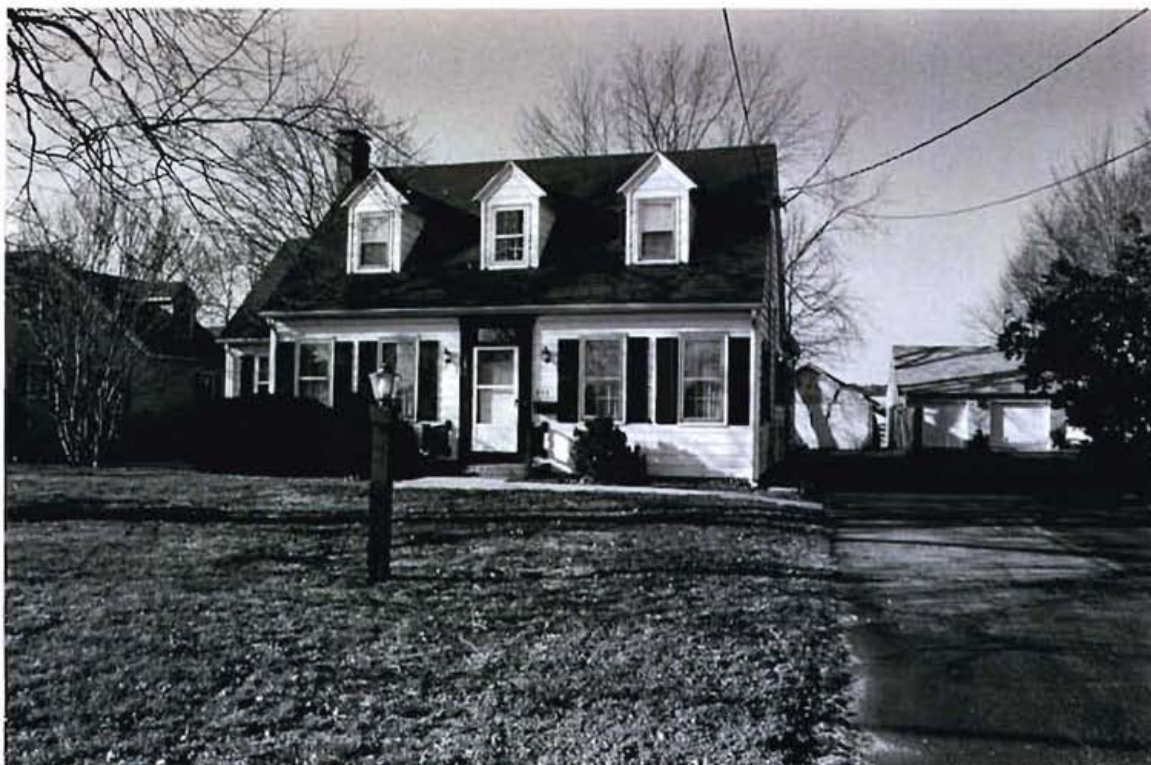
825 Route 9 (tax parcel 1-35-15-24) is a c. 1954, five bay, two story Cape Cod-style dwelling with vinyl exterior siding, six-over-six double-hung windows, and a side gable, asphalt shingle roof with an exterior brick chimney on the side (west) façade. A one story wood frame screen porch is seen off of the rear (north) façade.

The front (south) façade of the dwelling fronts Route 9, and features two single, six-over-six windows with fixed vinyl shutters on each side of the central entry. The four-panel, two-light entry features a metal screen door, fluted side detailing, and a fixed light transom. The second story contains three single dormers; each of these gable dormers has a single, six-over-six double-hung window.

Photograph 1: Lateral view of S-10128, facing north from Route 9. Note garage in background (shared driveway with S-10129).

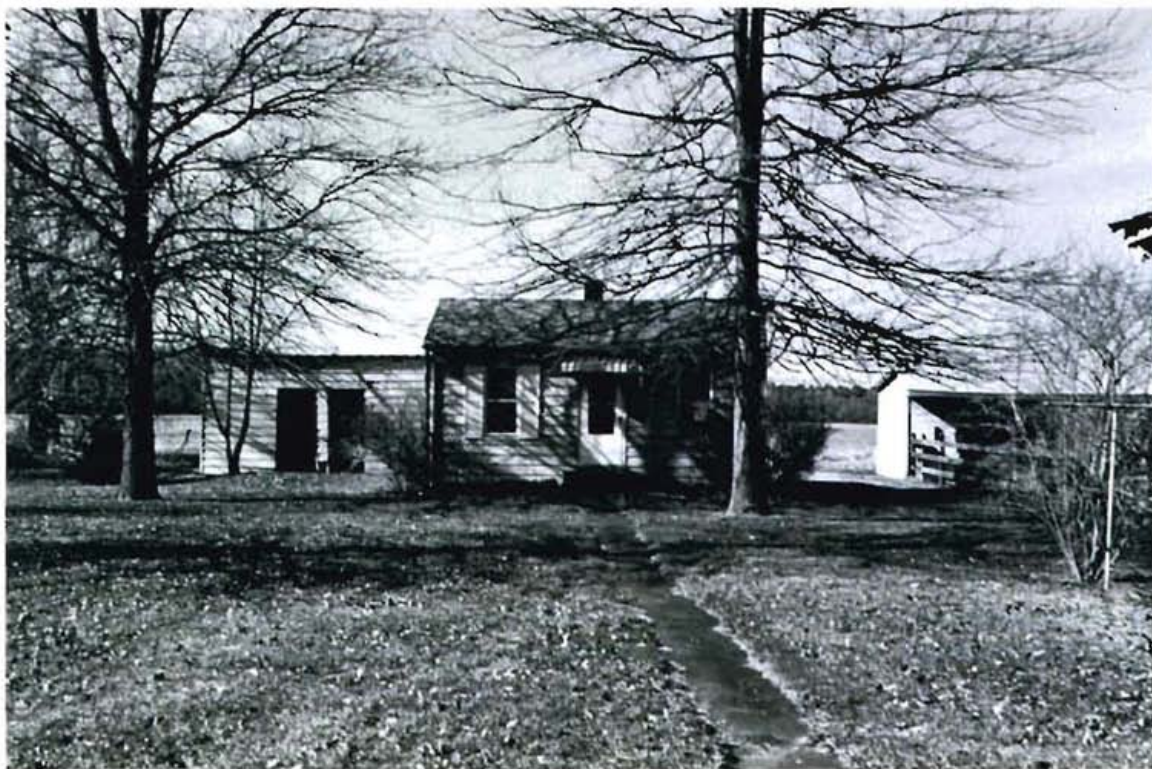
A one and one-half story guest cottage with attached one-story shed-roof storage area is situated to the north of the residence. The three-bay cottage is clad in weatherboard and has one-over-one windows and a central entrance. There is a center chimney on the rear eave.

Photograph 2: Elevation of guest cottage and storage shed at S-10128, facing north.

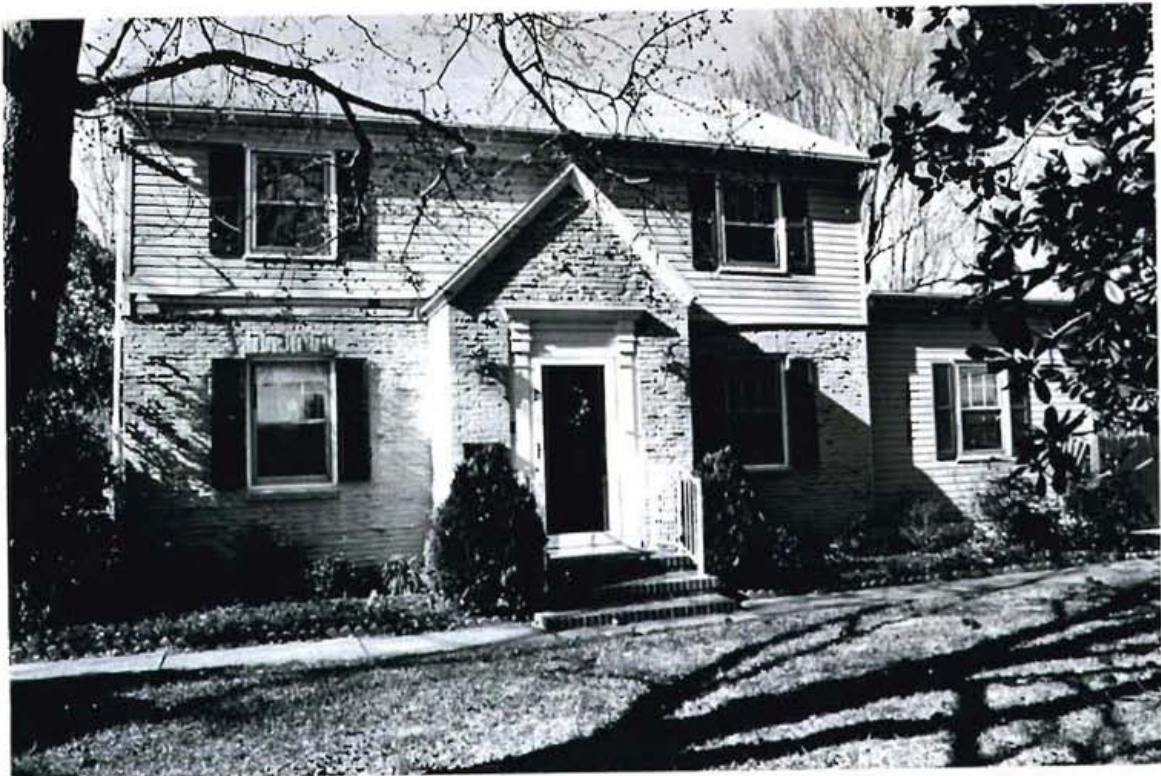
827 Route 9 (tax parcel 1-35-15-25) is a c. 1954, Colonial Revival, three bay, two and one-half story, single family dwelling with a clinker brick exterior on the first floor, and a wood shingle exterior on the second floor, and a side gable, asphalt shingle roof. All of the windows are six-over-one double-hung windows with fixed vinyl shutters, unless otherwise specified.

The front (south) façade faces Route 9, and features a centered, projecting entry, flanked by two single windows. The second story contains two single windows. The side (west) façade features similar fenestration; it contains two single windows on the first and second stories. The opposing (east) side façade has a one and one-half story, one bay addition with an asphalt shingle, side gable roof, clinker brick exterior, and a six-over-one double-hung window, flanked by fixed vinyl shutters.

Photograph 1: Lateral view of S-10129, facing north from Route 9.

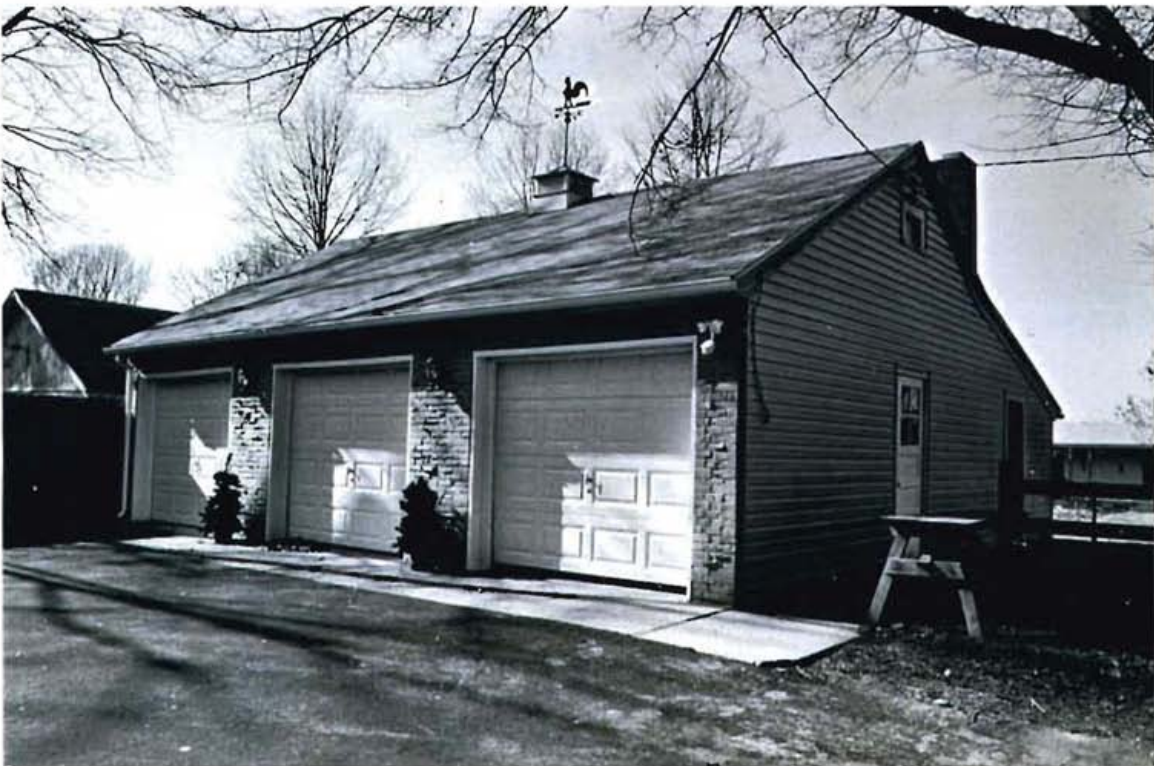
A one and one-half story, two bay vehicular garage is located northwest of the main dwelling. This garage features two large fiberglass vehicular doors along the front (south) façade, and a side gable, asphalt shingle roof.

Photograph 2: Lateral view of garage at S-10129, facing northwest.

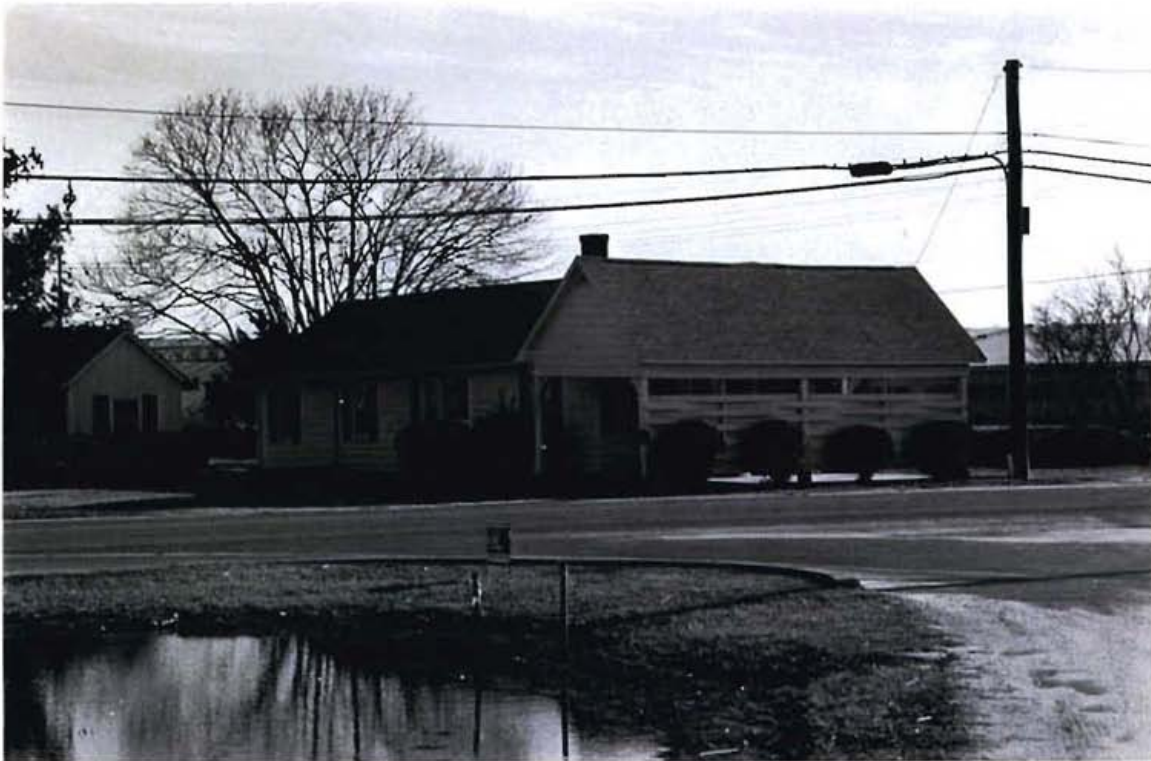
902 Route 9 (tax parcel 1-35-15-118) is a one-story, rectangular dwelling located at the southwest corner of the intersection of Airport Road (Road 319) and US Route 9 in Georgetown Hundred, Sussex County, Delaware. The dwelling is set back approximately 15 feet from Route 9 on a lightly wooded lot; the surrounding buildings are largely residential and of a similar time period. This dwelling was constructed c. 1950. 902 Route 9 has a front-gable roof covered with asphalt shingles and a perpendicular, attached large porte cochere on the front (north) façade. The porte cochere is also gable-roofed, and has partial lattice-style covering on the north side, forming the enclosure. A brick chimney projects from the roof ridge of the main portion of the house. A small shed-roofed addition with a secondary entry is located on the west façade. The windows are irregularly spaced on the side façades. Throughout the house, the windows are generally vinyl with one-over-one double-hung sash and louvered black shutters; occasionally paired windows are found. The house is covered with white aluminum siding.

Photograph 1: Lateral view of S-10130, facing south from the intersection of Route 9 and Road 319.

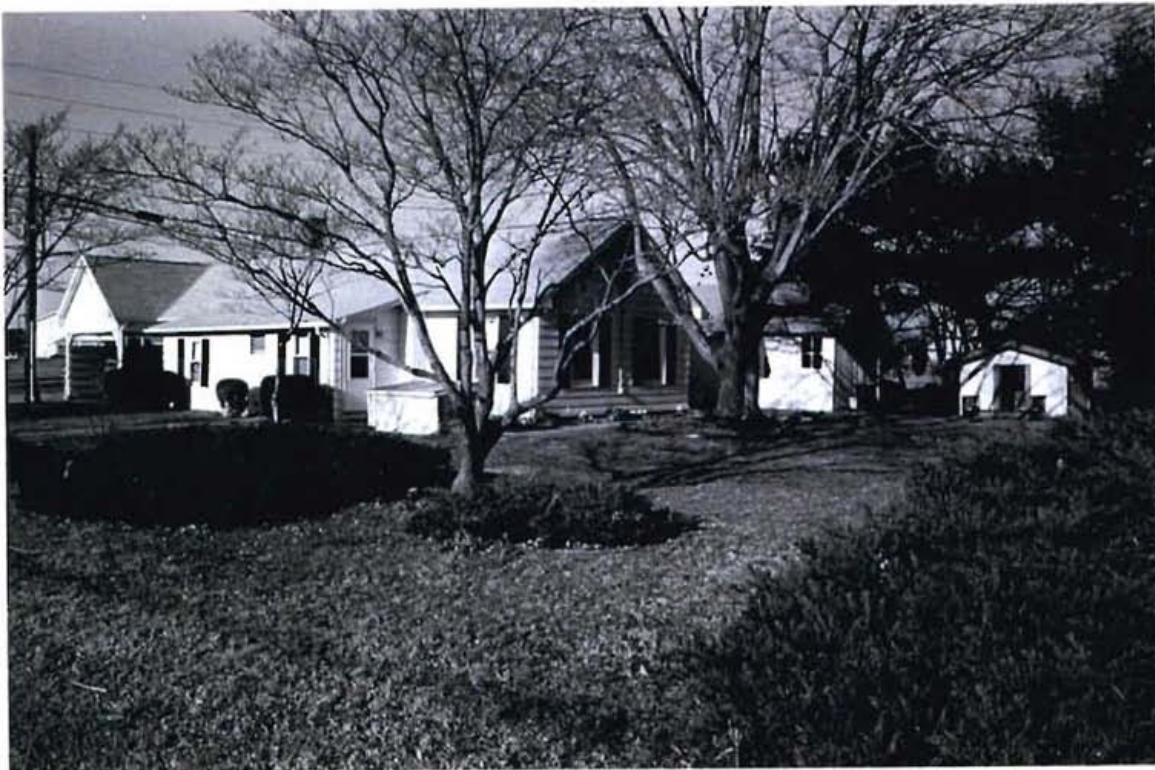
The property contains two outbuildings, located at a short distance to the east of the main dwelling. One is a large gable-roofed shed with irregular windows; one at the end of the west façade is a four-pane window, while the window on the north façade has one-over-one sash and shutters. The second outbuilding is a small gable-roofed shed with no windows and a central entry on the west façade.

Photograph 2: Lateral view of S-10130, facing northeast from Road 319. Note storage outbuildings.

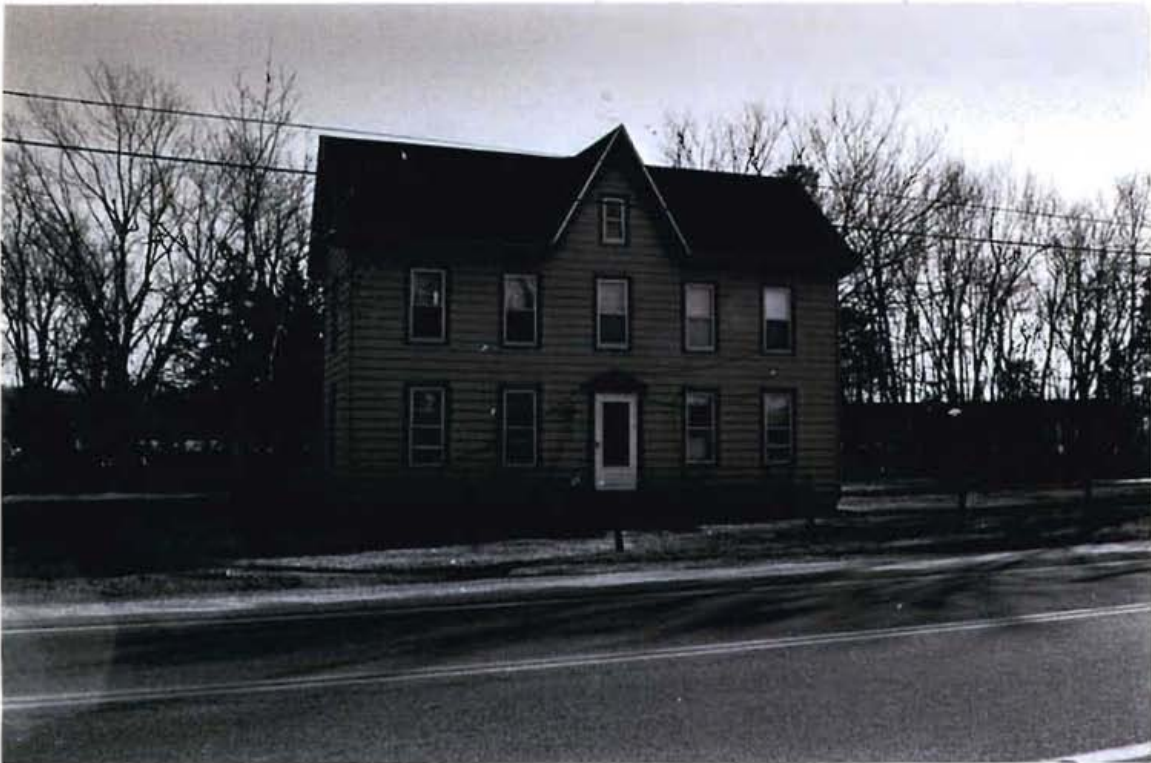
The Robert V. & Emily D. Wagner House (tax parcel 1-35-15-115.1) is a c. 1870, five bay, two and one-half story single-family I-house dwelling with an asphalt shingle, cross gable roof, boxed cornice with partial returns, aluminum exterior siding, and a brick foundation. A two and one-half story ell addition is seen off the rear (south) façade. A dwelling appears in a similar location to the Wagner House in the 1868 Beers' Atlas Map as the "T.B. Sipple" house; however, no further information has been found to date to support or refute this assertion. This property was previously surveyed by Carolyn Morgan of the Sussex County Preservation Office in July 1983, but no formal determination of eligibility was rendered.

The front (north) façade fronts Route 9 (also known as Market Street), and features four single one-over-one double hung windows on the first story, five single one-over-one double-hung windows on the second story, and a small one-over-one double-hung window in the third story cross gable with simple wood surrounds. The centered front entry features a paneled and glazed entry with a metal screen door, fluted side detailing, and a broken pediment.

Photograph 1: Lateral view of S-3156, facing south from Route 9.

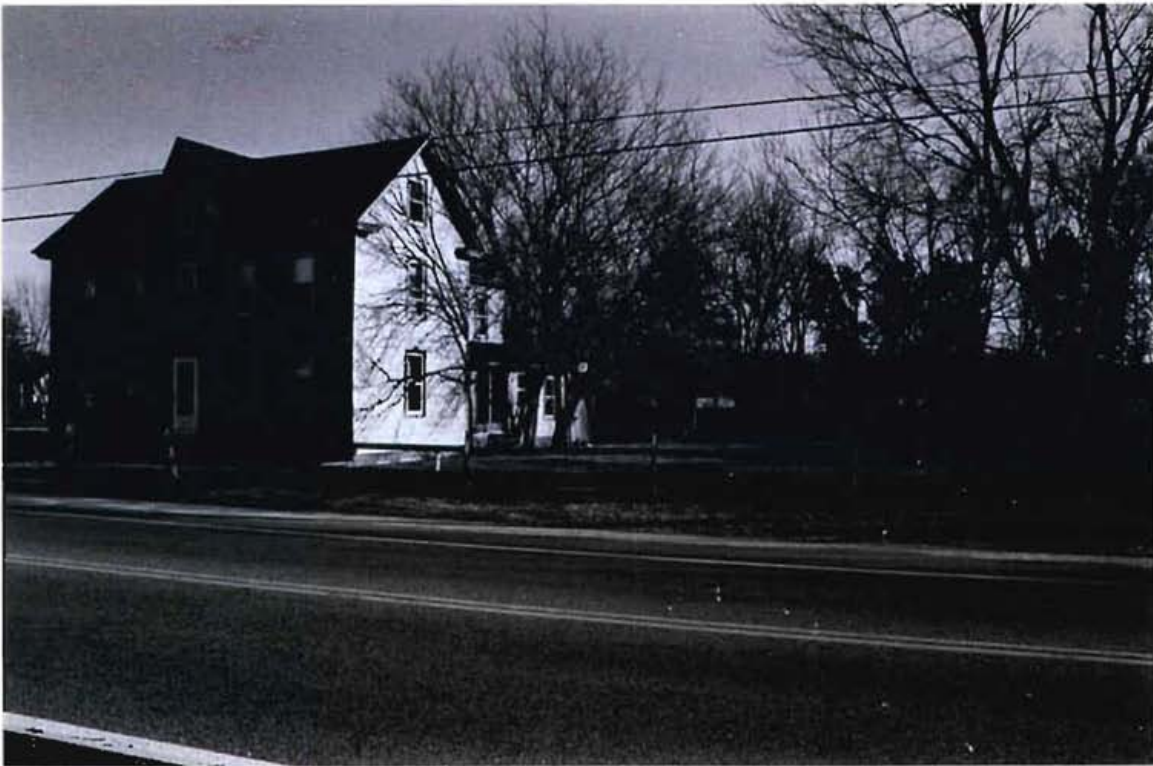
The main block of the side (east) façade contains a single one-over-one double-hung window on the first, second and third stories. The centered rear ell addition features an enclosed full-length shed roof porch addition along the first story; this enclosed porch has two paired one-over-one double-hung windows located along the southern end. The second story of the rear ell addition contains a single one-over-one double hung window on the second story along the southern end. An interior corbelled brick chimney is seen along the rear ell addition, located along the southern ridgeline of the roof.

Photograph 2: Lateral view of S-3156, facing southeast from Route 9.
